Manhole Inspection Summary

Manhole # S11MM1014MH

Location Address: **4750 PARK HEIGHTS AVE** Cross Street: **WOODLAND AVE**

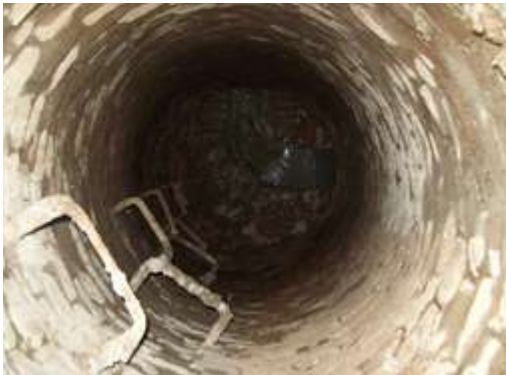
Top View

Steps Count: **7** Missing: **0** ☒ **Corroded**

Surcharge ☒ **Evidence Of Surcharge** Depth: **2** (ft.) ☐ Active Surcharge Present
